Alva Lake

Page 1: AIS Monitoring and Water
Clarity Report of September 9,
2015

Alva Lake AIS Monitoring and Water Clarity Report

WBIC: 968100
Previous AIS Findings: None
New AIS Findings: Banded Mystery Snail, Chinese Mystery Snail
Field Date: September 9, 2015
Field Crew: Stephanie Boismenu and Sara Mills, AIS Project Assistants,
Oneida County Land and Water Conservation Department
Report by: Sara Mills

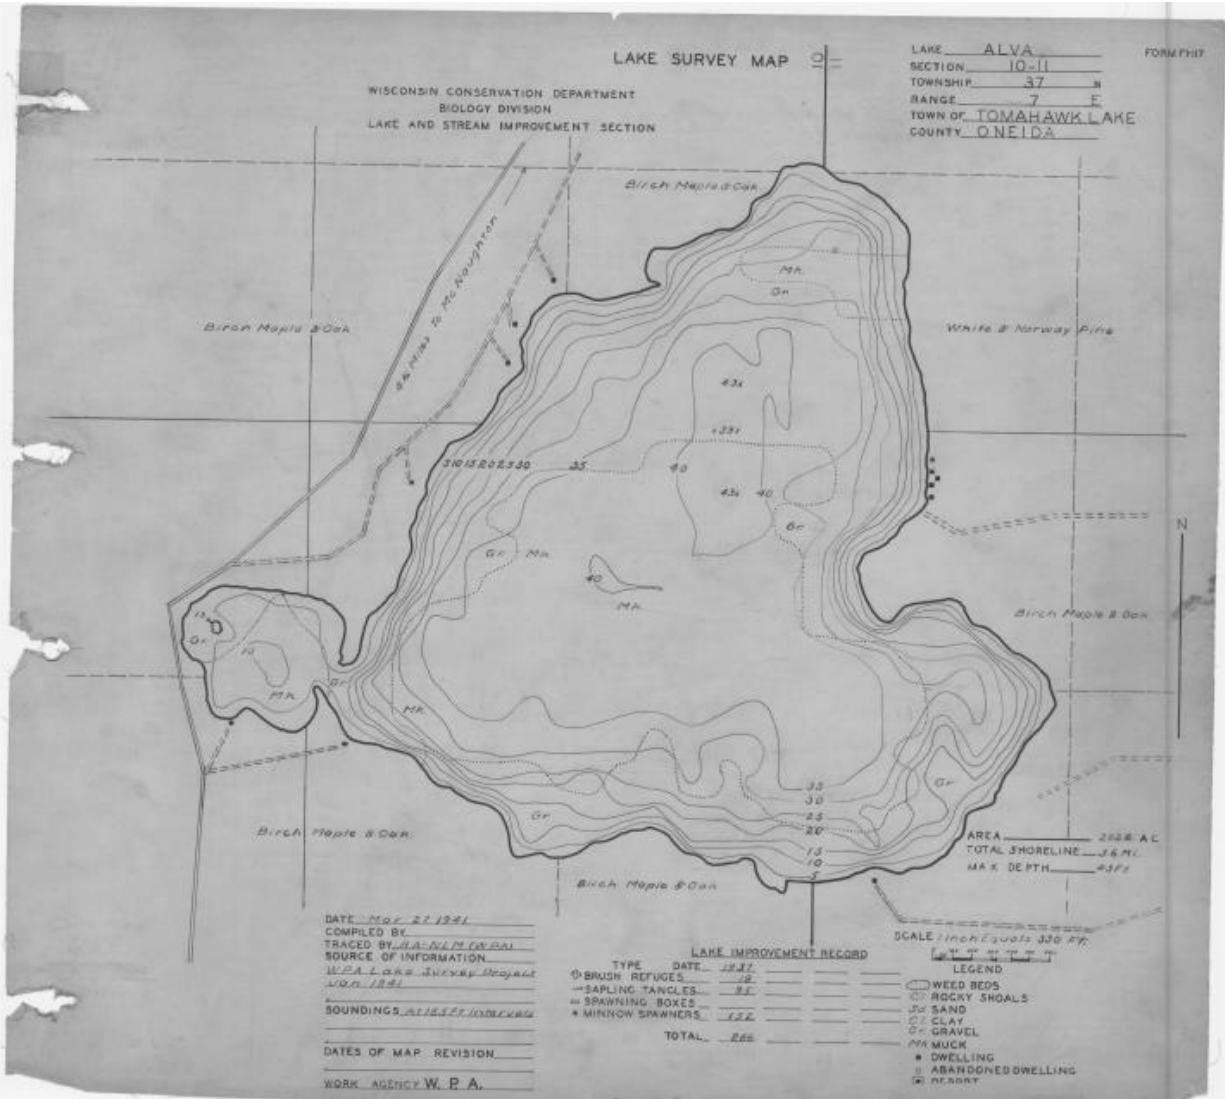
Figure 2. Bathymetric map of Alva Lake.

Map Source: Wisconsin Department of Natural Resources (608) 266-2621, Alva Lake – Oneida County, Wisconsin – DNR Lake Map, Date – March 27, 1941 – Historical Lake Map.

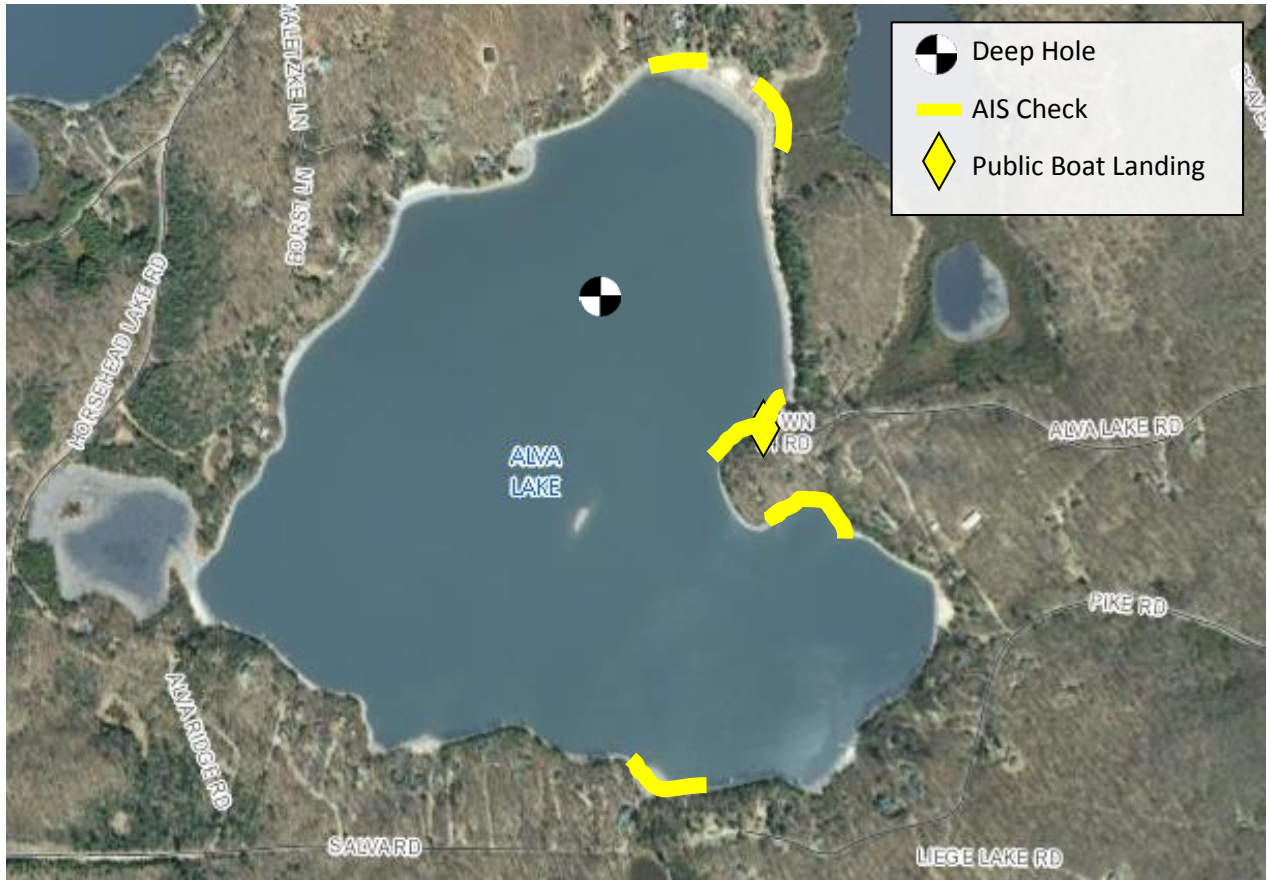
Figure 3. Map of Alva Lake with the deep hole, AIS checks, and public boat landing labeled.

The conditions for lake monitoring were partly cloudy with wind at 12-13 mph. We entered the lake from a public boat landing (Figure 3). Using the bathymetric map (Figure 2) and the depth finder, Stephanie and I navigated as close as we could to the deep hole of the lake. Due to the high wind speeds, we could not find the deep hole of 43 feet. We dropped anchor to keep the canoe from drifting while taking the measurements. I collected a GPS location for our measurements, a Secchi disk reading for water clarity, and dissolved oxygen and temperatures for water quality (Table 1).

Deep Hole GPS Coordinates: 45.71029644, -89.59135756

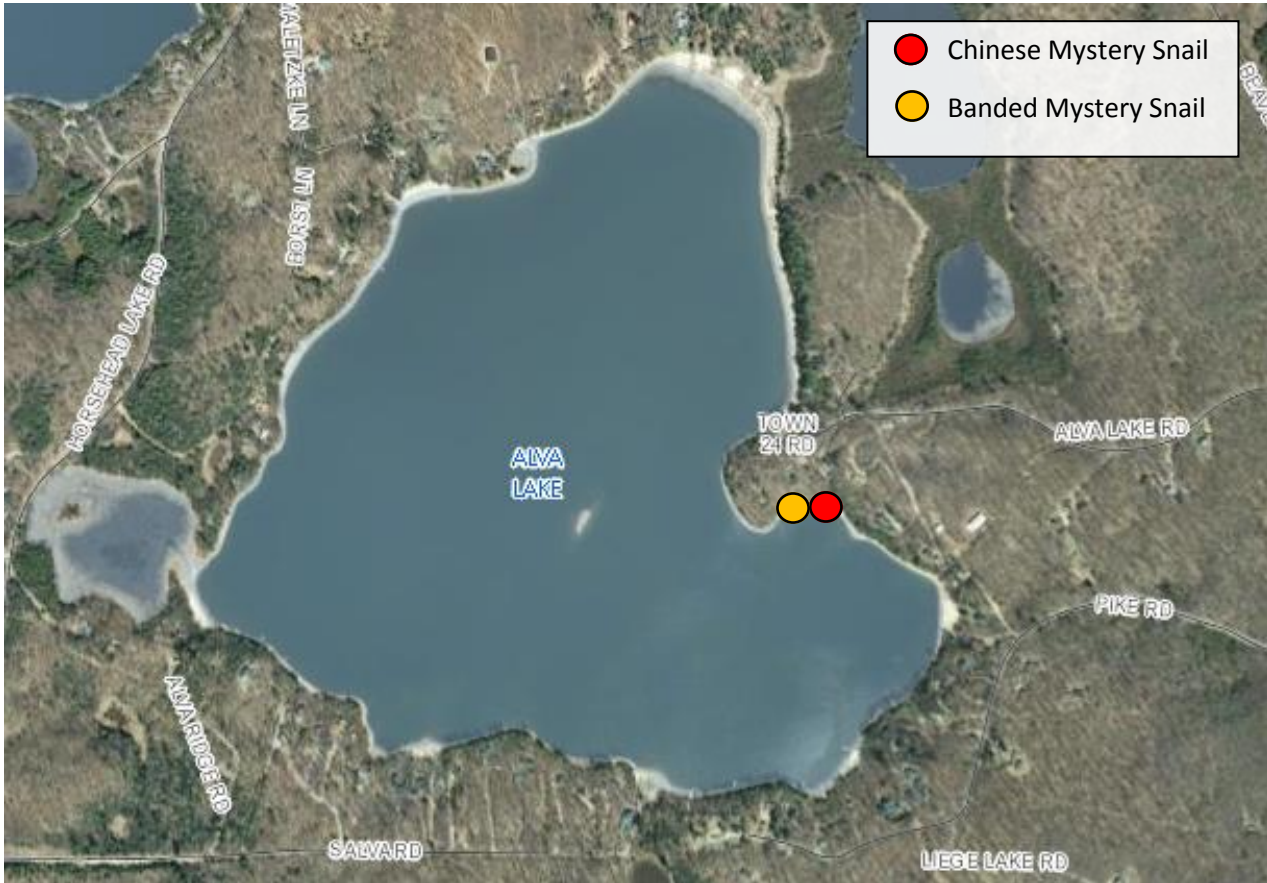
Figure 4. Map of Alva Lake with new AIS discoveries.

We discovered both Chinese mystery snails and banded mystery snails and brought them to the DNR station for identification confirmation. The new discoveries can be seen in Figure 4.

Chinese Mystery Snail GPS Coordinates: 45.70771954, -89.58718850

Banded Mystery Snail GPS Coordinates: 45.70771954, -89.58718850
