# Big Carr Lake

## **Big Carr Lake AIS Monitoring and Water Clarity Report**

Field Date: August 9<sup>th</sup>, 2017  
WBIC: 971600  
Previous AIS Findings: Chinese Mystery Snail, Freshwater Jellyfish, Purple Loosestrife, Rusty Crayfish  
New AIS Findings: None  
Field Crew: Aubrey Nycz, AIS Project Leader, and Thomas Boisvert, AIS Project Assistant, Oneida County Land and Water Conservation Department  
Report By: Thomas Boisvert

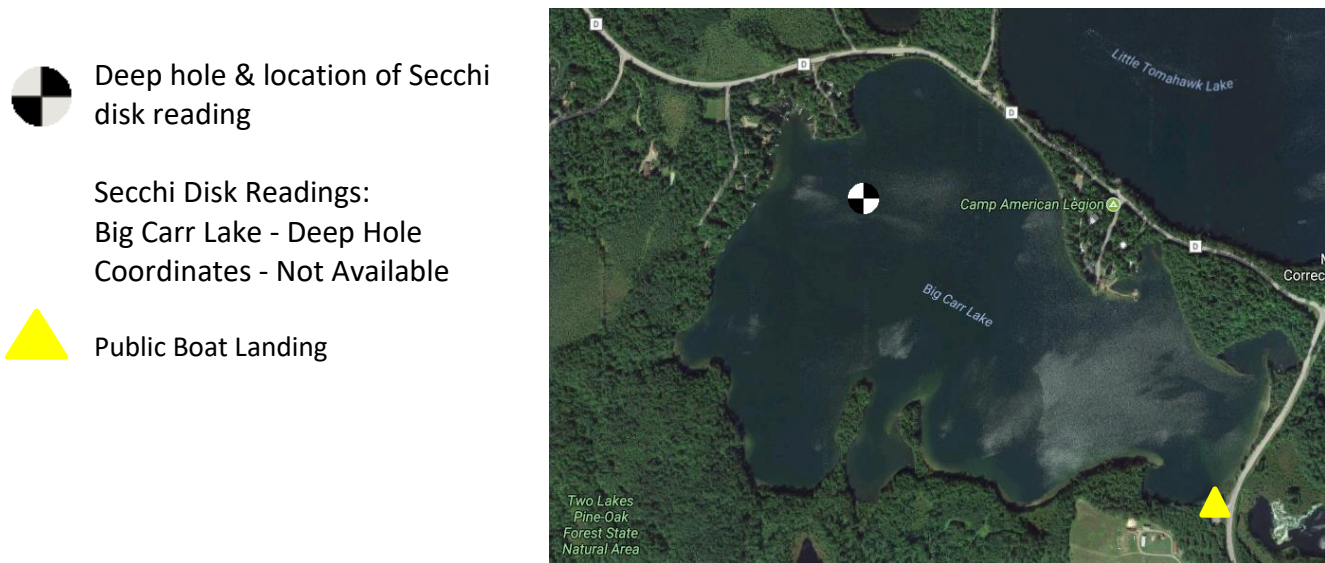
Figure 2. Map of Big Carr Lake with the location of the Secchi disk reading labeled.

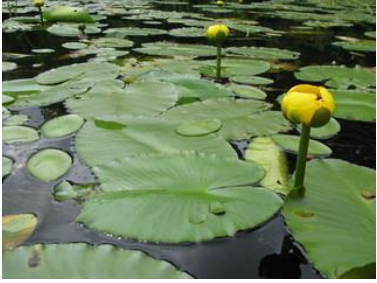
Common Name Scientific Plant Name	Description	Image
<p>Bullhead Pond Lily (Spatterdock)</p> <p><i>Nuphar variegata</i></p>	<p>An aquatic plant with heart-shaped leaves that can grow to be 15 inches long. This plant also has a yellow, cup-shaped flower. This plant is native.</p>

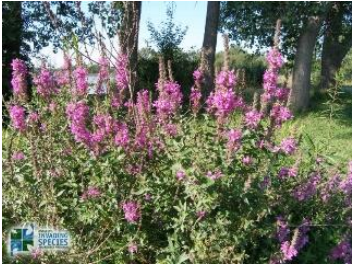
<p>Photo Credit: Jomegat's Weblog</p>
<p>Purple Loosestrife</p> <p><i>Lythrum salicaria</i></p>	<p>A flowering plant with a square or 6-sided stem and smooth leaves. Flowers tend to be a pinkish purple with 6 petals. This plant is invasive!</p>

Aubrey and I did observe Purple Loosestrife on Big Carr Lake, however, this invasive was already known to have been established here. We were glad to see that no new invasive species were present at this time, however, the Purple Loosestrife will need to be controlled as it seems to be spreading rapidly. Besides the Purple Loosestrife, the lake seems to be healthy, and some native plants were present and thriving. There were not many aquatic plants due to the sandy/rocky substrate of this lake, but the three most common plants we observed were Purple Loosestrife, Water Smartweed, and Bullhead Pond Lilies. These plants can be seen below in table 1.
