Buffalo Lake

Page 1: AIS Monitoring and Water
Clarity Report of August 2nd,
2017

Buffalo Lake AIS Monitoring and Water Clarity Report

Field Date: August 2nd, 2017
WBIC: 974200
Previous AIS Findings: Chinese Mystery Snail
New AIS Findings: Purple Loosestrife
Field Crew: Aubrey Nycz, AIS Project Leader, and Thomas Boisvert, AIS Project Assistant, Oneida County Land and Water Conservation Department
Report By: Thomas Boisvert

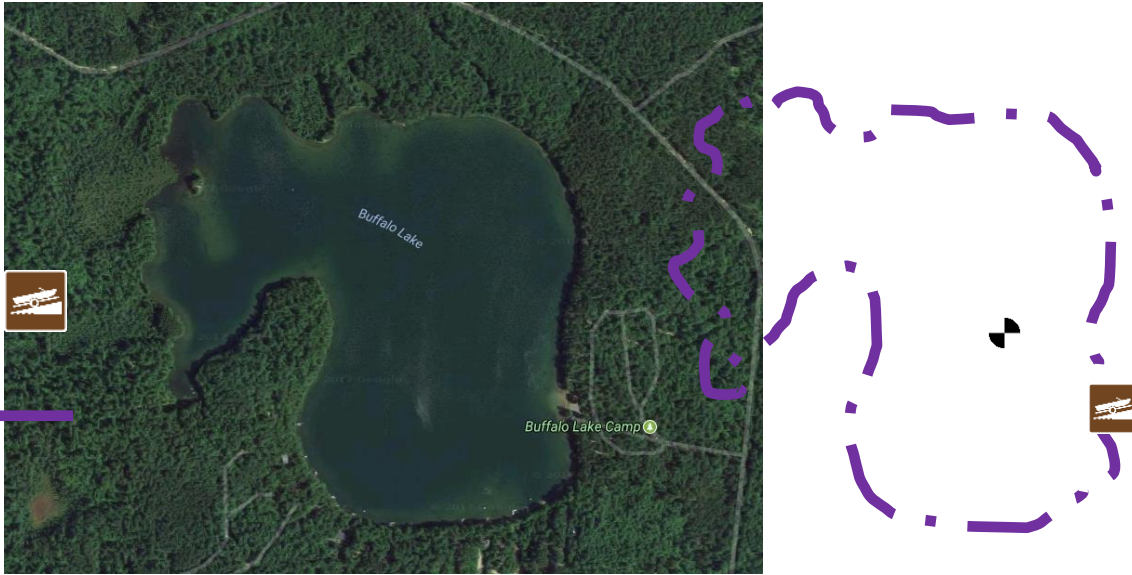
Figure 2. Map of Buffalo Lake with boat landing and location of Secchi disk reading labeled.

Purple Loosestrife was found along 80% of the shoreline on Buffalo Lake.

Deep hole & location of Secchi disk reading

Boat Landing

Purple Loosestrife

Aubrey and I did observe some Chinese Mystery Snails in Buffalo Lake, however, this invasive was already known to have been established here. Unfortunately we did find a new invasive species on Buffalo Lake. Aubrey and I noticed that Purple Loosestrife appeared to be taking over Buffalo Lake. Aubrey and I estimate that 80% of the shoreline is composed of Purple Loosestrife. This is very concerning, and the WDNR should consider high removal of Purple Loosestrife on the lake within the immediate years. While on the lake, Aubrey and I did clip all visible flowers and remove some of the larger patches.

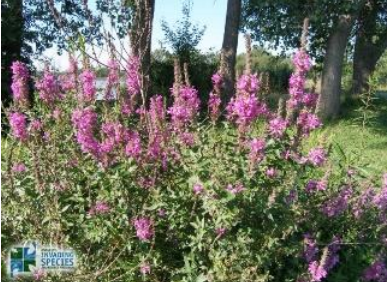
<p>Photo Credit: www.nwplants.com</p>
<p>Purple Loosestrife</p> <p><i>Lythrum salicaria</i></p>	<p>A flowering plant with a square or 6-sided stem and smooth leaves. Flowers tend to be a pinkish purple with 6 petals. This plant is invasive!</p>
