Clawson Lake

Clawson Lake AIS Monitoring and Water Clarity Report

Field Date: June 21st, 2016
WBIC: 976900
Previous AIS Findings: None
New AIS Findings: None
Field Crew: Aubrey Nycz, AIS Project Leader, and Thomas Boisvert, AIS Project Assistant, Oneida County Land and Water Conservation Department
Report By: Thomas Boisvert

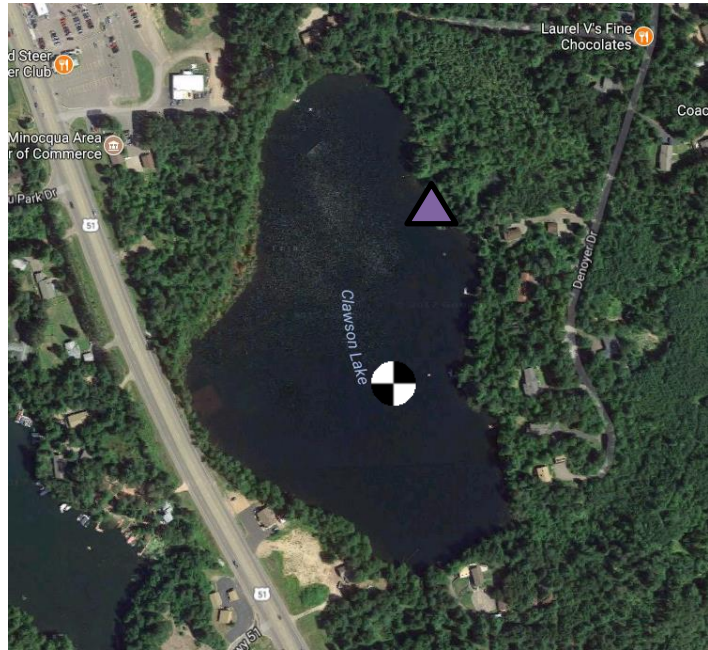
Figure 2. Map of Clawson Lake with boat landing, Secchi disk/Dissolved oxygen site, and purple loosestrife area all labeled below

Aubrey and I unfortunately did find one invasive species present on Clawson Lake. The invasive that we had found was purple loosestrife, and there were approximately 6 plants along the Eastern shoreline (see lake map). We were unsure what to expect as this was the first time Clawson Lake has ever been monitored, and it was not a good sign seeing purple loosestrife present. Besides the few plants of purple loosestrife, the lake seems to be healthy and many native plants were present and thriving. Blue Flag Iris, Large Purple Bladderwort, and Purple Loosestrife were some of the plants Aubrey and I had seen while on Clawson Lake. These plants can be seen below in table 1.

Aquatic Invasive Species: Purple Loosestrife was found along the Eastern shoreline of Clawson Lake.

Public boat landing

Deep hole & location of Secchi disk reading

Purple Loosestrife

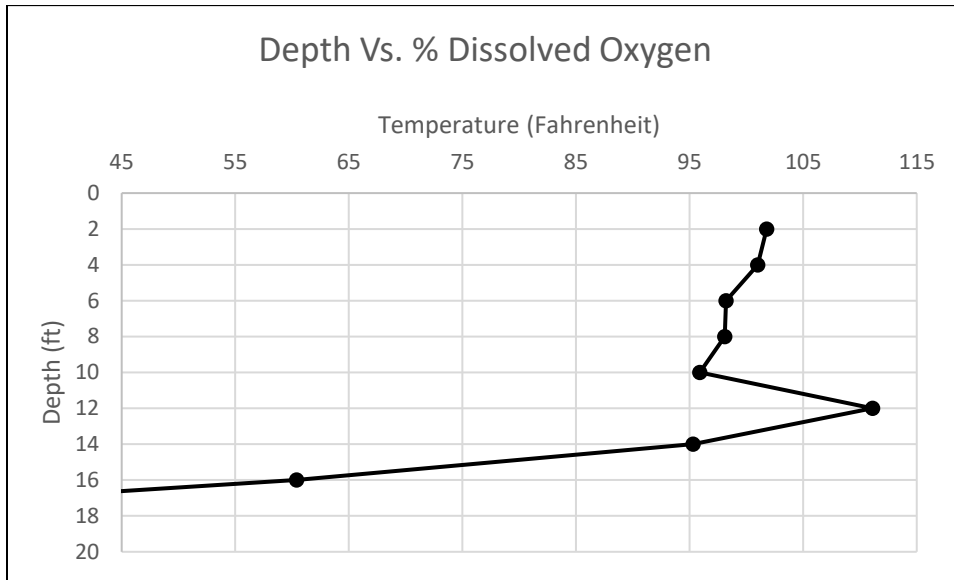
Graph 1

in the lake would be under stress, and thankfully both of these measurements were relatively average in nature. These measurements mean there should be no concern for the health of Clawson Lake. The Secchi disk reading was 12 feet, and the dissolved oxygen readings can be found in table 2. Graphs displaying water quality can also be viewed below (graphs 1-3).
