Page 1: AIS Monitoring and Water
 Clarity Report of July 15, 2016

Emma Lake AIS Monitoring and Water Clarity Report

WBIC: 983500

Field Date: July 15, 2016

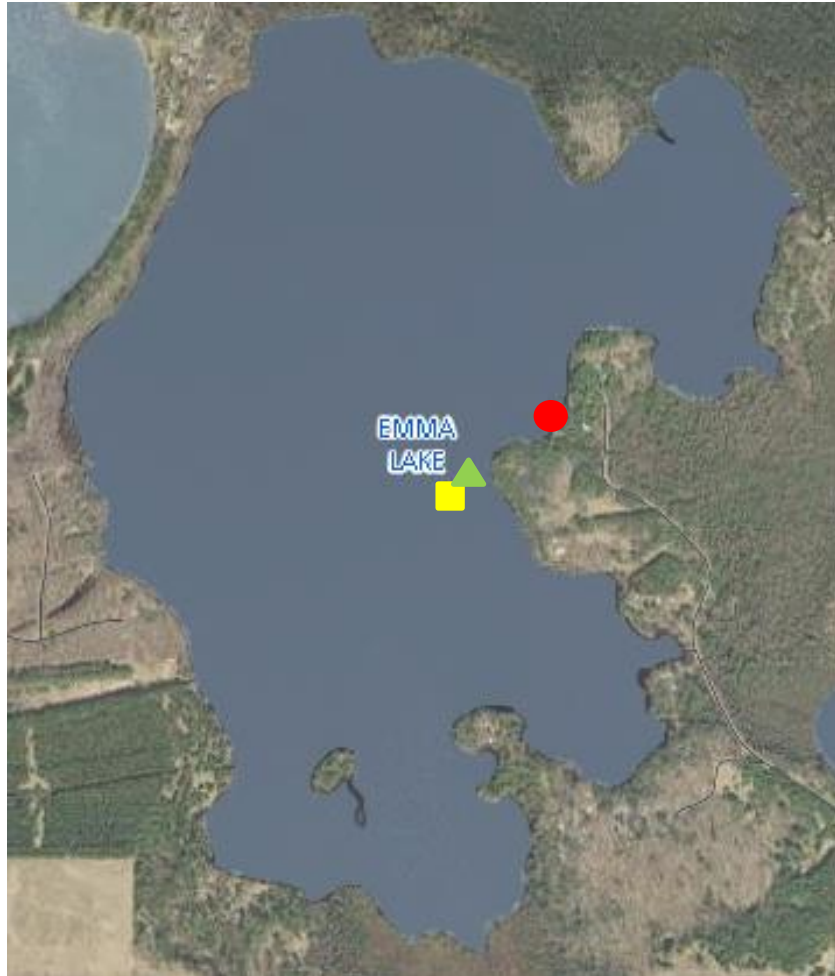
Figure 2. Map of Emma Lake; the red circle shows where we entered the lake, the yellow square shows where the deep hole can be found, the green triangle shows where we obtained our Secchi Disk coordinates.
