Hemlock Lake

Page 1: AIS Monitoring and Water
Clarity Report of June 21st, 2017

Hemlock Lake AIS Monitoring and Water Clarity Report

Field Date: June 21st, 2017
WBIC: 989200
Previous AIS Findings: None
New AIS Findings: None
Field Crew: Aubrey Nycz, AIS Project Leader, and Thomas Boisvert, AIS Project Assistant, Oneida County Land and Water Conservation Department
Report By: Thomas Boisvert

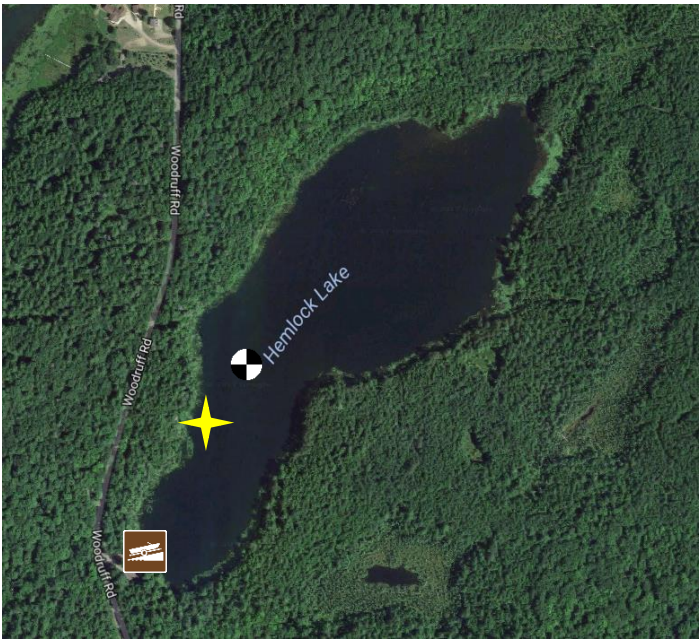
Figure 2. Map of Hemlock Lake with boat landing and location of Secchi disk reading labeled.

Public boat landing
-

Deep hole & location of Secchi disk reading
- Secchi Disk Readings:
Hemlock Lake - Deep Hole
Coordinates - Not Available
-

Rake Location

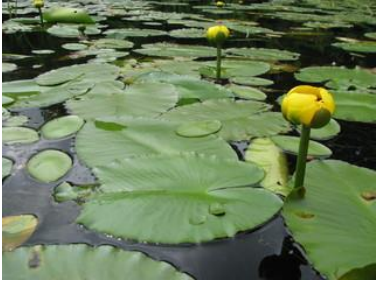
<i>Nuphar variegata</i>	Bullhead Pond Lily (Spatterdock)

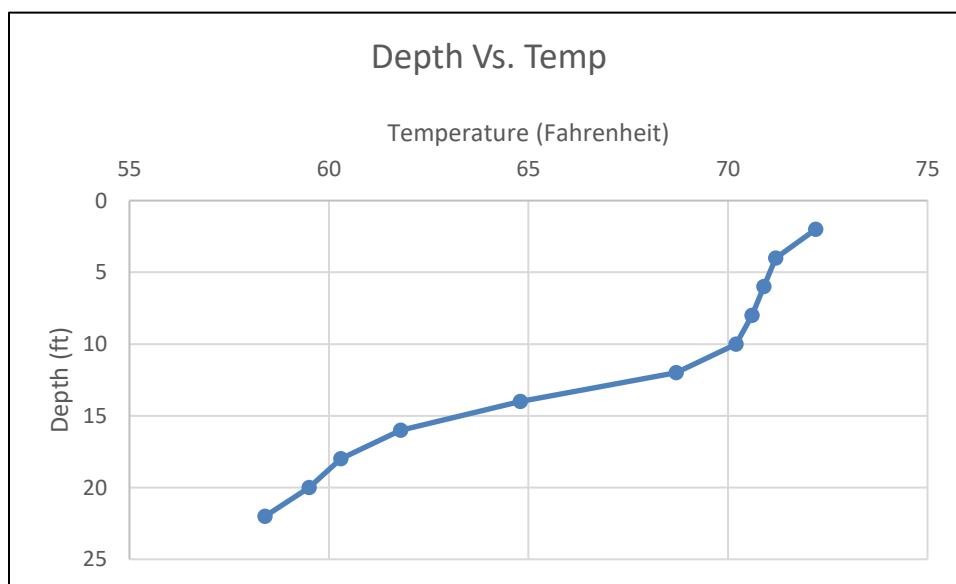
Graph 1

To observe the water clarity and quality of Hemlock Lake, Aubrey and I went to the deep hole towards the middle of the lake. After locating the deep hole with our sonar unit, we used a Secchi disk to measure clarity and a dissolved oxygen meter to measure water health. Oxygen is needed for a healthy fish population, and also for plants to respire at night as well. The measurements from the dissolved oxygen meter can tell us if the organisms in the lake would be under stress, and thankfully both of these measurements were relatively average in nature, and there should be no concern for the health of Hemlock Lake. The Secchi disk reading was 16 feet, and the dissolved oxygen readings can be found in table 2. Graphs displaying water quality can also be viewed below (graphs 1-3).
