Mud Lake

Mud Lake AIS Monitoring and Water Clarity Report

Field Date: July 25th, 2018
WBIC: 1544000
Previous AIS Findings: None
New AIS Findings: Eurasian Water Milfoil, Chinese Mystery Snail
Field Crew: Aubrey Nycz, AIS Project Leader and Jody Partin, AIS Project Assistant,
Oneida County Land and Water Conservation Department
Report By: Jody Partin

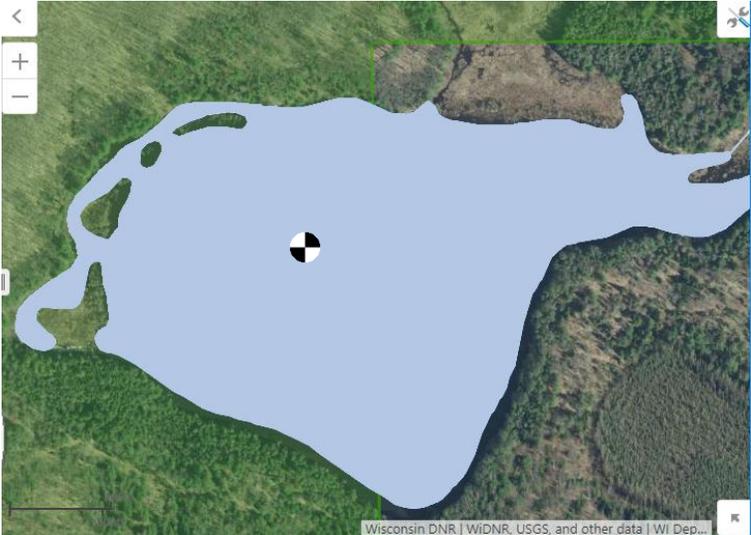
Figure 2. Map of Mud Lake with location of Secchi disk reading labeled.

Secchi: The Secchi reading on this lake was 10.5 feet out of a 26 foot maximum depth. The water color was a yellowish color, and appeared clear when glancing across the lake.

Deep hole & location of Secchi disk reading
