Papkee Lake

Papkee Lake AIS Monitoring and Water Clarity Report

Field Date: June 21st, 2016
WBIC: 1546100
Previous AIS Findings: None
New AIS Findings: None
Field Crew: Aubrey Nycz, AIS Project Leader, and Thomas Boisvert, AIS Project Assistant, Oneida County Land and Water Conservation Department
Report By: Thomas Boisvert

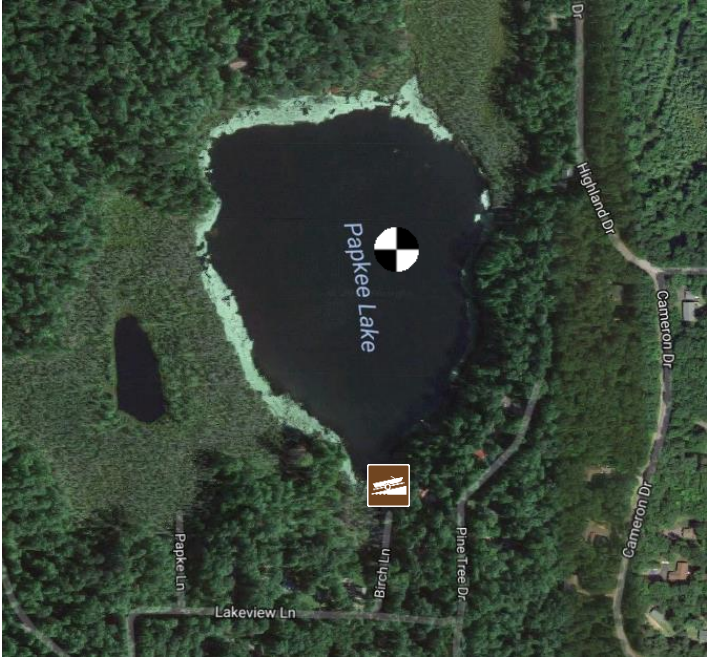
Figure 2. Map of Papkee Lake with boat landing and location of Secchi disk reading labeled.

Secchi: The Secchi reading on this lake was 6 feet out of a 22 foot maximum depth. The water color was a bluish color, and appeared clear when glancing across the lake.

Public boat landing
-

Deep hole & location of Secchi disk reading

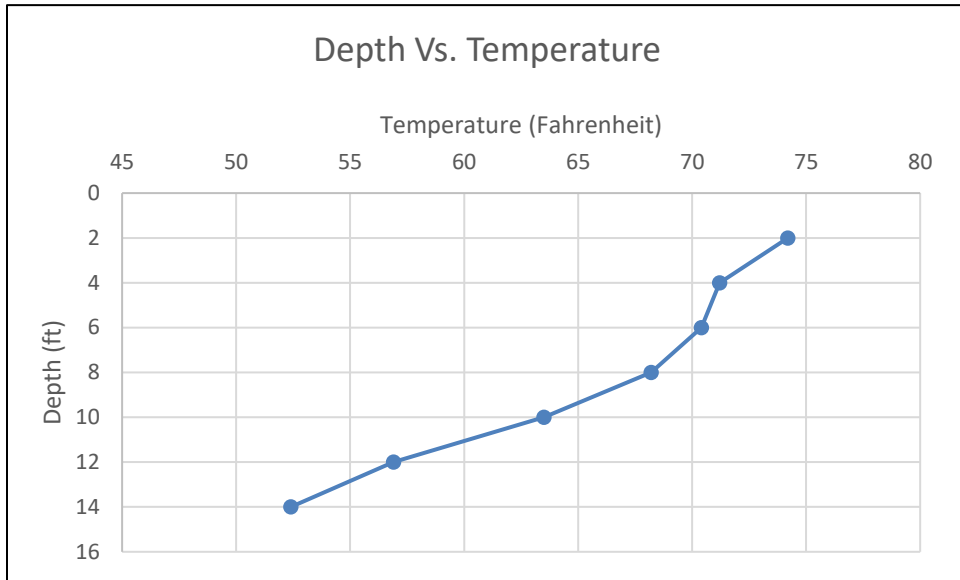
Graph 1

at night as well. The measurements from the dissolved oxygen meter can tell us if the organisms in the lake would be under stress, and thankfully both of these measurements were relatively average in nature, and there should be no concern for the health of Papkee Lake. The Secchi disk reading was 6 feet, and the dissolved oxygen readings can be found in table 2. Graphs displaying water quality can also be viewed below (graphs 1-3).

Depth (Feet)	Dissolved Oxygen Levels (mg/L)	Temperature (F)	Percent Dissolved Oxygen
2	8.36	74.2°	104.5%
4	8.21	71.2°	99.3%
6	7.57	70.4°	90.8%
8	7.65	68.2°	89.6%
10	8.75	63.5°	97.1%
12	5.28	56.9°	54.2%
14	0.14	52.4°	1.4%
