Pickerel Lake

Page 1: AIS Monitoring and Water
Clarity Report of July 26th, 2018

Pickerel Lake AIS Monitoring and Water Clarity Report

Field Date: July 26th, 2018
WBIC: 1583000
Previous AIS Findings: Chinese Mystery Snail
New AIS Findings: None
Field Crew: Aubrey Nycz, AIS Project Leader, and Thomas Boisvert, AIS Project Assistant, Oneida County Land and Water Conservation Department
Report By: Thomas Boisvert

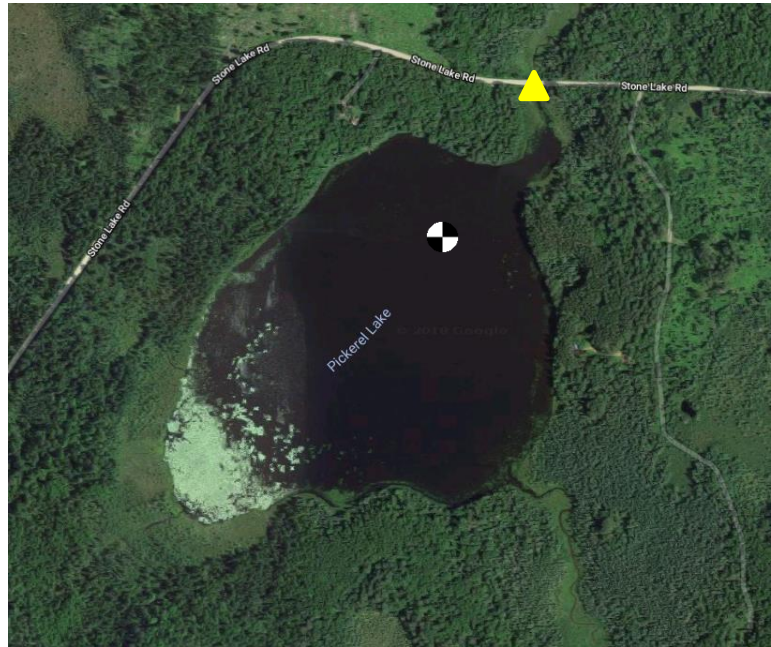
Figure 2. Map of Pickerel Lake with the location of the Secchi disk reading labeled.

Secchi: The Secchi reading on this lake was 1 foot out of a 5 foot maximum depth. The water color was a brownish color, and was murky when glancing across the lake.

Deep hole & location of Secchi disk reading
- Secchi Disk Readings:
Pickerel Lake - Deep Hole
Coordinates - Not Available
-

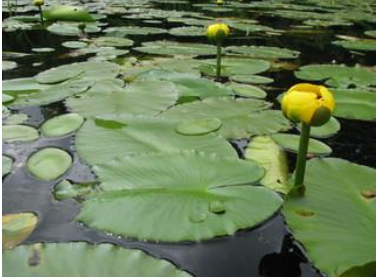
Common Name Scientific Plant Name	Description	Image
<p>Bullhead Pond Lily (Spatterdock)</p> <p><i>Nuphar variegata</i></p>	<p>An aquatic plant with heart-shaped leaves that can grow to be 15 inches long. This plant also has a yellow, cup-shaped flower. This plant is native.</p>
