Pier Lake

Page 1: AIS Monitoring and Water
Clarity Report of August 12,
2015

Pier Lake AIS Monitoring and Water Clarity Report

WBIC: 1529700
Previous AIS Findings: None
New AIS Findings: Chinese Mystery Snail and Unconfirmed Yellow Iris
Field Date: August 12, 2015
Field Crew: Stephanie Boismenu and Sara Mills, AIS Project Assistants,
Oneida County Land and Water Conservation Department
Report by: Sara Mills

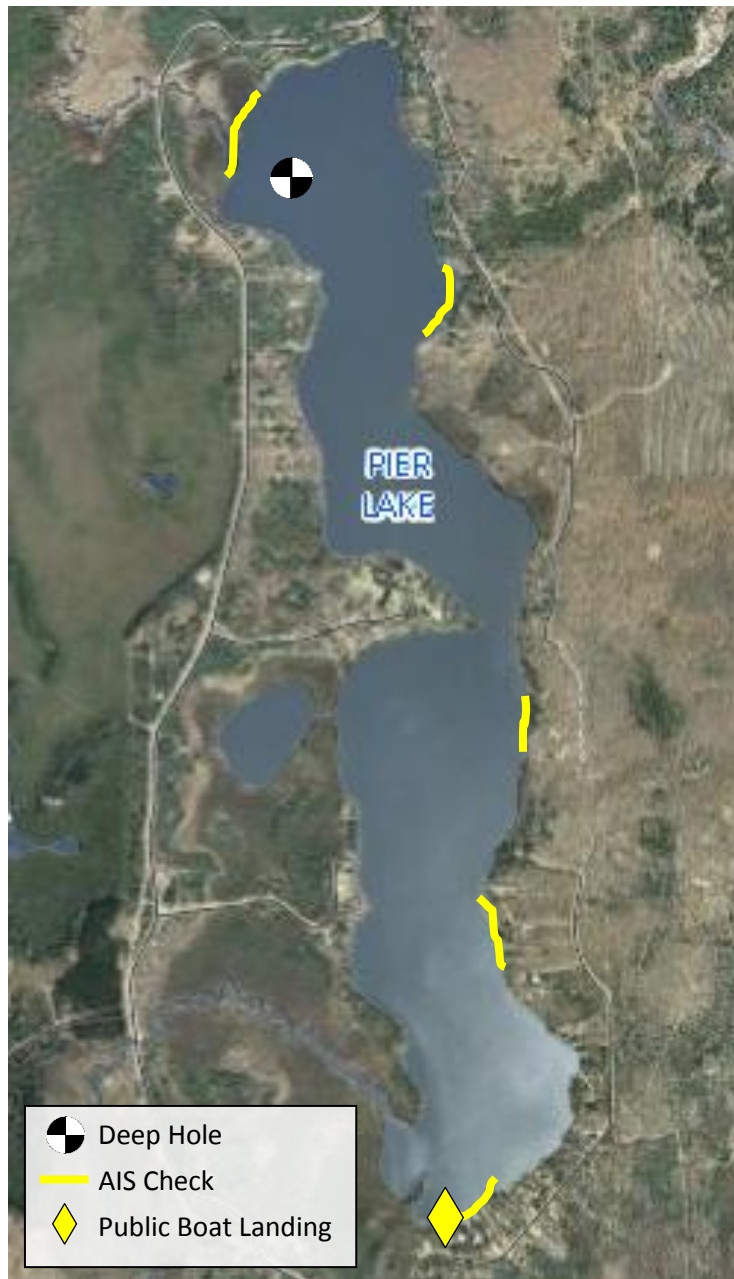
Figure 3. Map of Pier Lake. The deep hole site, locations monitored for AIS presence/absence checks, and public boat landing are labeled.

Deep Hole GPS Coordinates: 45.74528367, -89.98303852

After data collection, we paddled to five locations on the lake shore to perform an AIS presence/absence check. The protocol for this process is to complete a visual inspection of the littoral zone along 100 feet of the shoreline in each area. We chose five areas around private docks with motorized watercrafts, inlets and outlets, and the public boat landing (Figure 3). For the five locations of AIS presence/absence checks, we meandered the shoreline via walking along the shoreline, using an aquascope to eliminate the glare on the water surface, looking through vegetation, and checking around and under solid surfaces. In addition to the five presence/absence checks, we also visually inspected from the canoe for the entire shoreline of the lake.

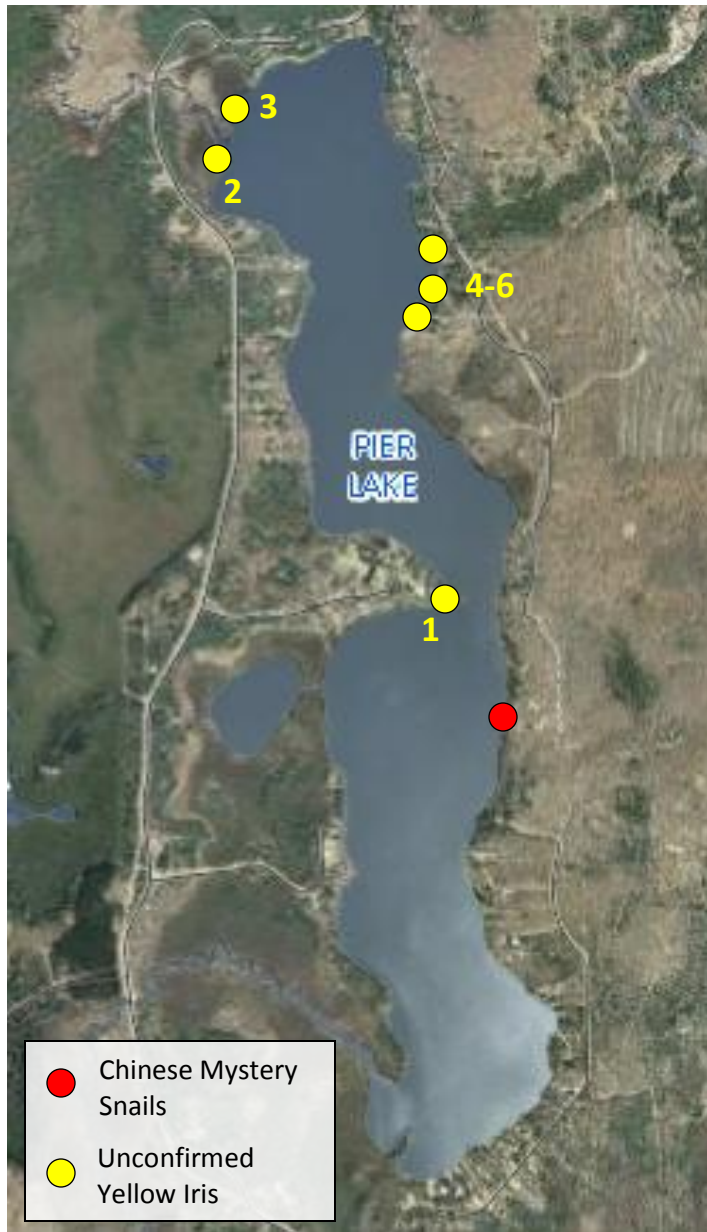
We discovered Chinese mystery snails during one of our presence/absence checks (Figure 4). We found three live specimens and brought them to the DNR station in Rhinelander for proper identification since it was not listed as an invasive in the lake. We also found many yellow iris plants on the shoreline of much of the lake (Figure 4). We obtained a sample from a private shoreline and brought it to the DNR station in Rhinelander for identification because they are not listed as an invasive in the lake as well. The homeowner was present and confirmed to us that the flowers bloom yellow. However, when we got the results back from the DNR, they reported it to be native iris. It is possible that there was a mistake in identification or that Stephanie and I accidentally obtained a native plant growing within the invasive stand. Another sample will need to be obtained and brought to the DNR station to confirm that the iris is the invasive yellow iris.

Figure 4. Map of Pier Lake with new AIS discoveries.

Chinese Mystery Snail GPS Coordinates: 45.73245620, -89.97570670

Unconfirmed Yellow Iris #1 GPS Coordinates: 45.73538392, -89.97762004

Unconfirmed Yellow Iris #2 GPS Coordinates: 45.74538447, -89.98535267

Unconfirmed Yellow Iris #3 GPS Coordinates: 45.74655714, -89.98495989

Unconfirmed Yellow Iris #4-6 GPS Coordinates: 45.74547543, -89.97865859 (entire bay)
