Shallow Lake

Shallow Lake AIS Monitoring and Water Clarity Report

Field Date: August 23rd, 2017
WBIC: 1016700
Previous AIS Findings: None
New AIS Findings: None
Field Crew: Aubrey Nycz, AIS Project Leader, Thomas Boisvert, AIS Project Assistant, and Derek Thorn, AIS Project Assistant, Oneida County Land and Water Conservation Department
Report By: Thomas Boisvert

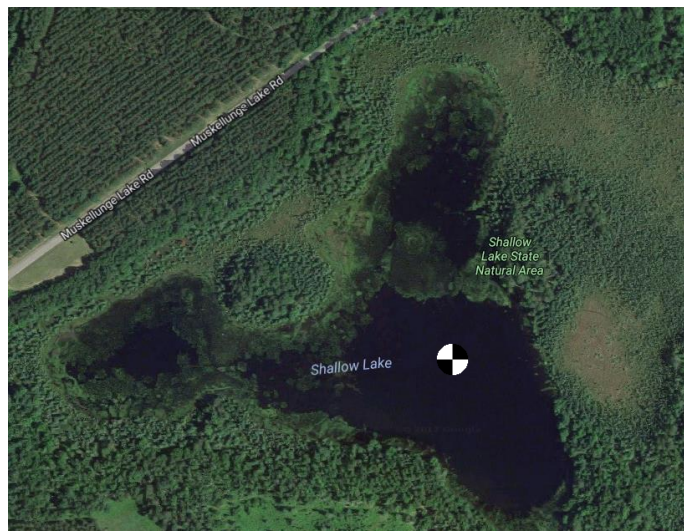
Figure 2. Map of Shallow Lake with the location of Secchi disk reading labeled.

Deep hole & location of Secchi disk reading

Secchi Disk Readings:
Shallow Lake - Deep Hole
Coordinates - Not Available

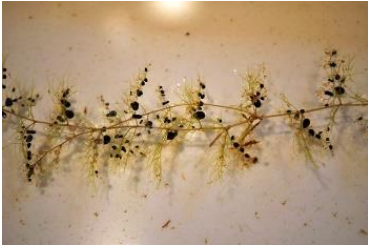
<p>Photo Credit: Joseph A. Marcus</p>
<p>Common Bladderwort</p> <p><i>Utricularia macrorhiza</i></p>	<p>An aquatic plant with leaves containing small sacks that trap small invertebrates. This plant usually has unrooted stems that easily tangle with other plants. In the water, this plant tends to look cloudy or slimy. This plant is native.</p>

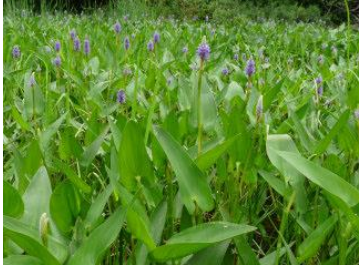
<p>Photo Credit: frenchhill.org</p>
<p>Pickrel Weed</p> <p><i>Pontederia cordata</i></p>	<p>An aquatic plant with thin, bright green leaves. Emergent leaves tend to be arrow shaped with 6 parted, blue flowers. This plant is native.</p>
