## **Sweeny Lake AIS Monitoring and Water Clarity Report**

Field Date: July 12<sup>th</sup>, 2017  
WBIC: 1589600  
Previous AIS Findings: Chinese Mystery Snail, Purple Loosestrife  
New AIS Findings: None  
Field Crew: Aubrey Nycz, AIS Project Leader, and Thomas Boisvert, AIS Project Assistant, Oneida County Land and Water Conservation Department  
Report By: Thomas Boisvert

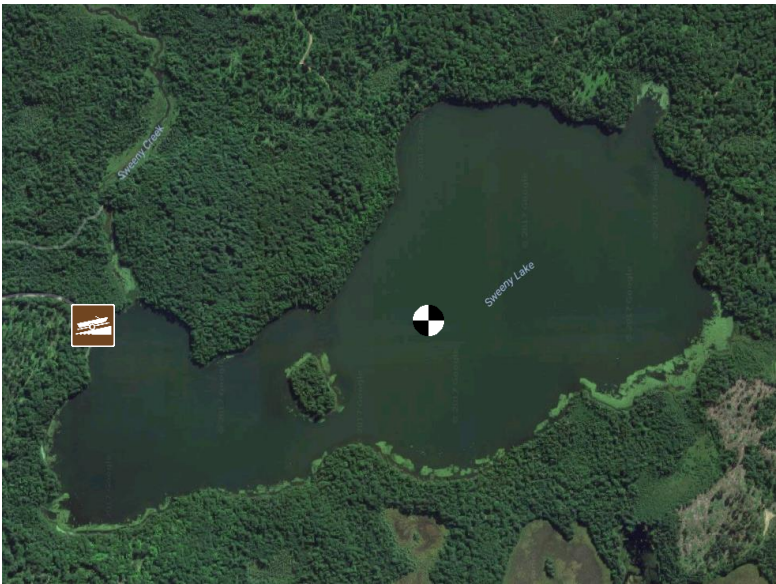
Figure 2. Map of Sweeny Lake with the boat landing and location of Secchi disk readings labeled.

Public boat landing
  -

Deep hole & location of Secchi disk reading
- Secchi Disk Readings:  
Hemlock Lake - Deep Hole  
Coordinates - Not Available

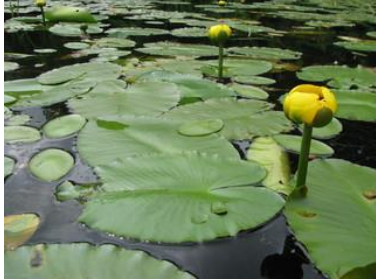
<p>Bullhead Pond Lily (Spatterdock) <i>Nuphar variegata</i></p>	<p>An aquatic plant with heart-shaped leaves that can grow to be 15 inches long. This plant also has a yellow, cup-shaped flower. This plant is native.</p>

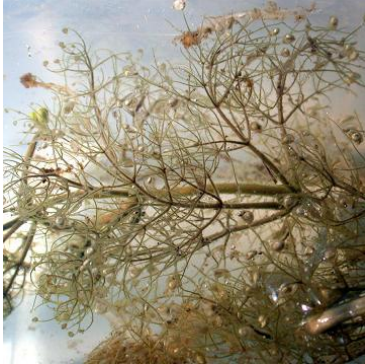
<p>Large Purple Bladderwort <i>Utricularia purpurea</i></p>	<p>An aquatic plant with leaves containing small sacks that trap small invertebrates. This plant usually has unrooted stems that easily tangle with other plants. In the water, this plant tends to look cloudy or slimy. This plant is native.</p>
